Special Situation Report

U.S. Army Corps of Engineers
Omaha District

Low Dissolved Oxygen Levels in Summer Powerplant Discharges from Fort Randall Dam, South Dakota

Report Number: CENWO-ED-HA/SSR/Fort Randall Tailwaters/2010

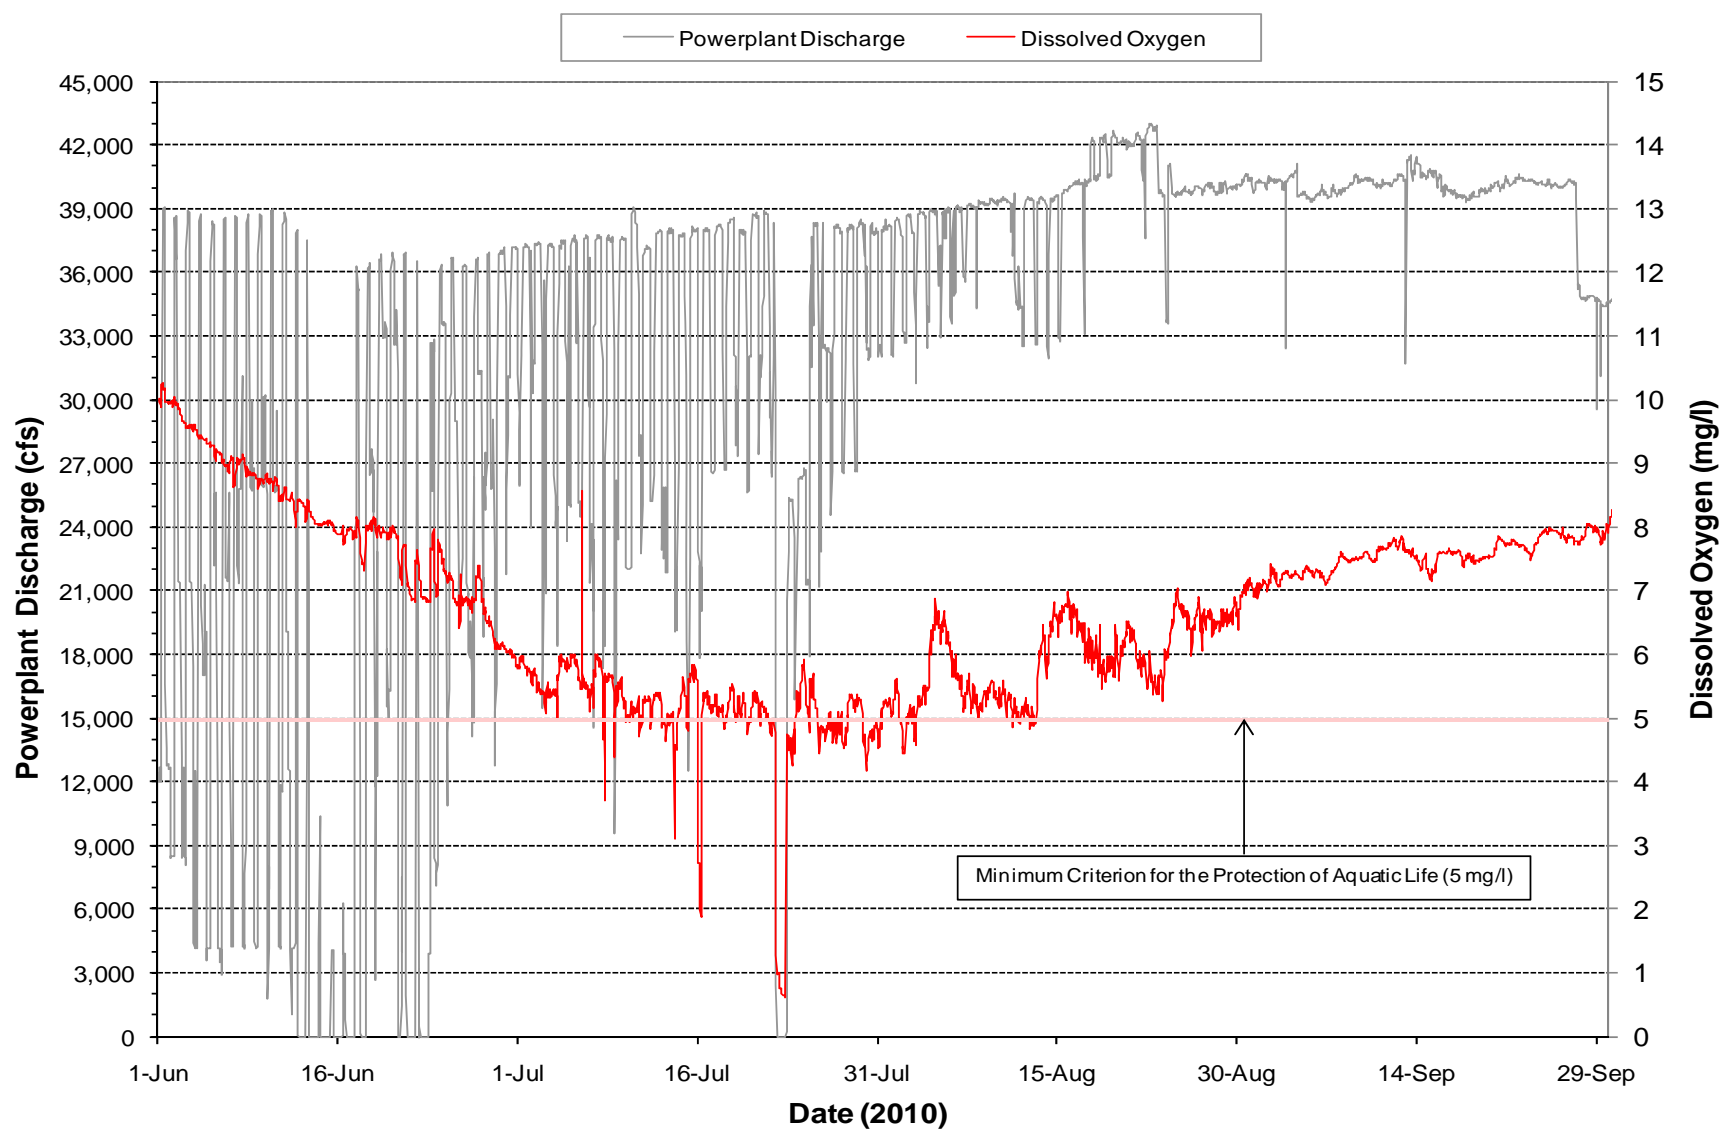
Water quality conditions monitored at the Fort Randall powerplant in 2010 were reviewed. Figures 2 and 3 show hourly water temperature and dissolved oxygen levels monitored from June 1 through September 30, 2010. Figure 4 shows hourly dissolved oxygen and powerplant discharge for the period July 1 through August 30, 2010. As seen in Figures 2 - 4, the monitored water temperature and dissolved oxygen were more dependent on dam discharge in June and July. Dissolved oxygen levels continually decreased during June, and first went below South Dakota's 5 mg/l dissolved oxygen water quality standard minimum criterion on July 8. The lowest dissolved oxygen occurrences tend to be associated with lower dam discharges.

Figure 3. Hourly powerplant discharge and dissolved oxygen monitored in the Fort Randall powerplant “raw water” supply line during the period June 1 through September 30, 2010.

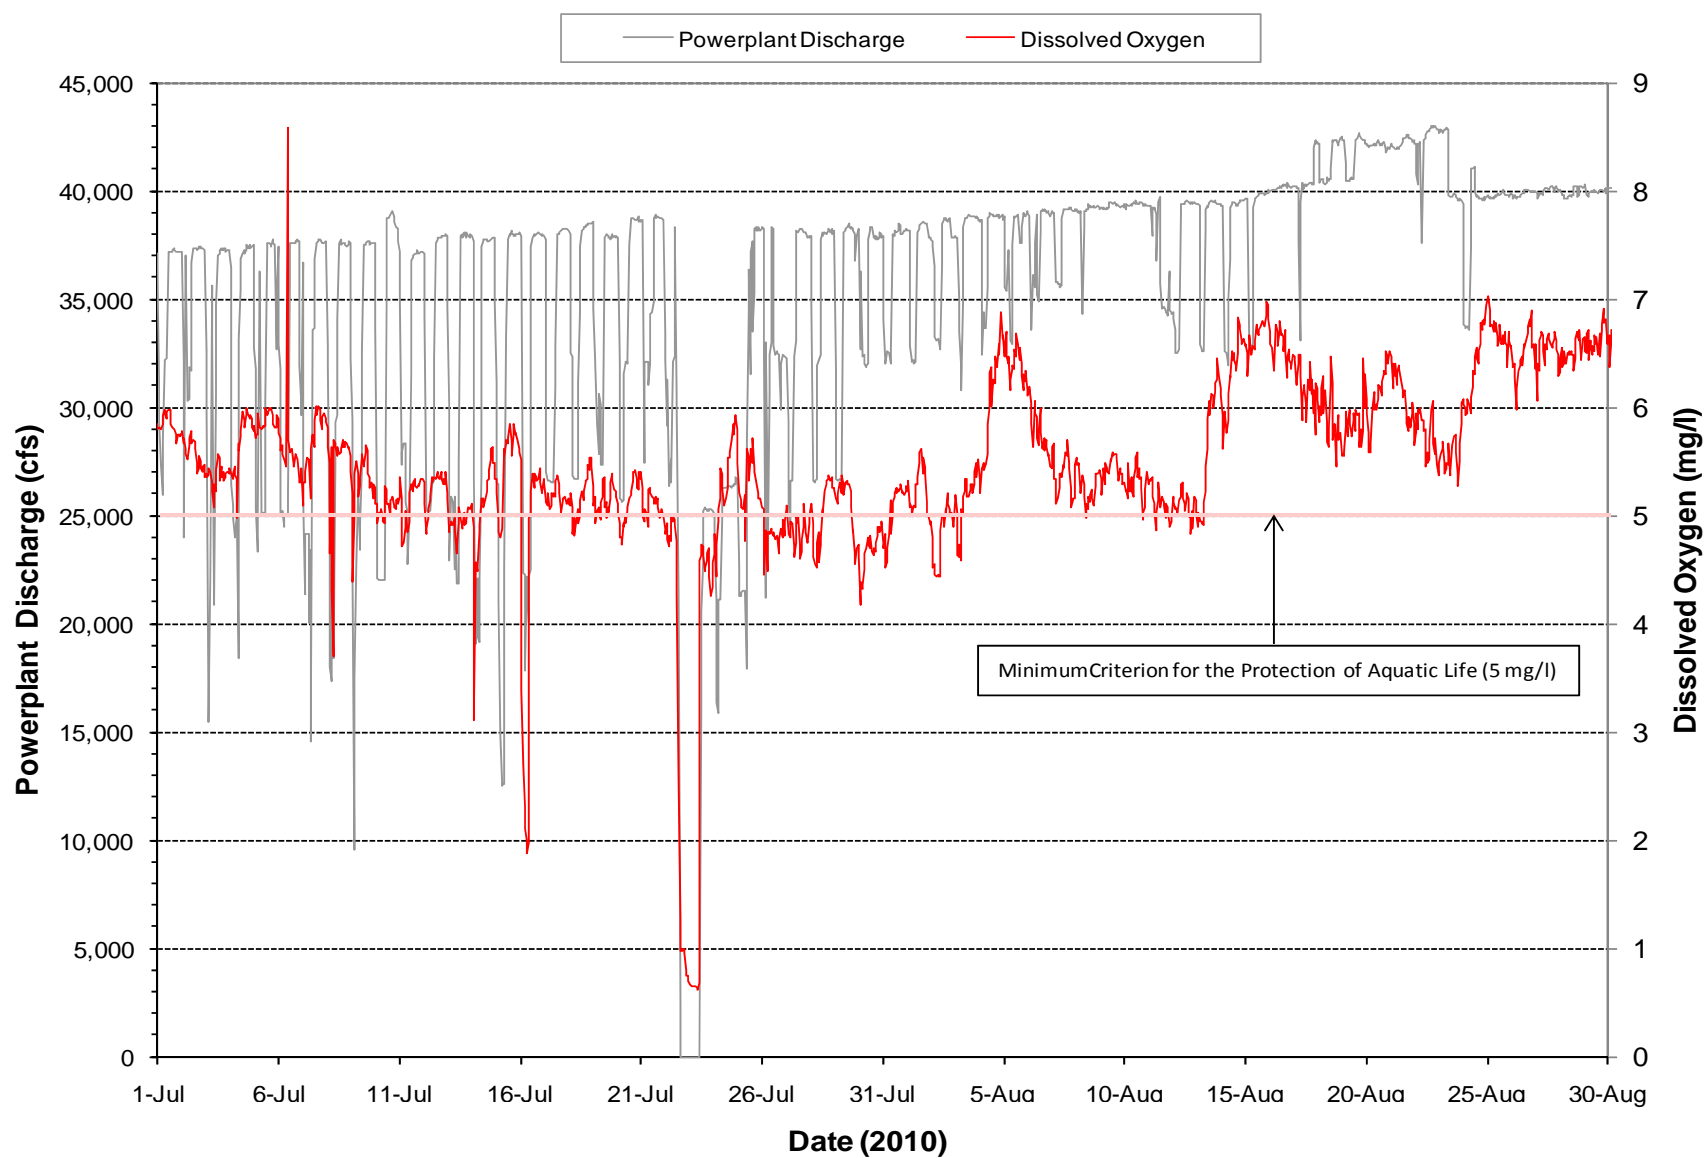
Figure 4. Hourly powerplant discharge and dissolved oxygen monitored in the Fort Randall powerplant “raw water” supply line during the period July 1 through August 30, 2010.

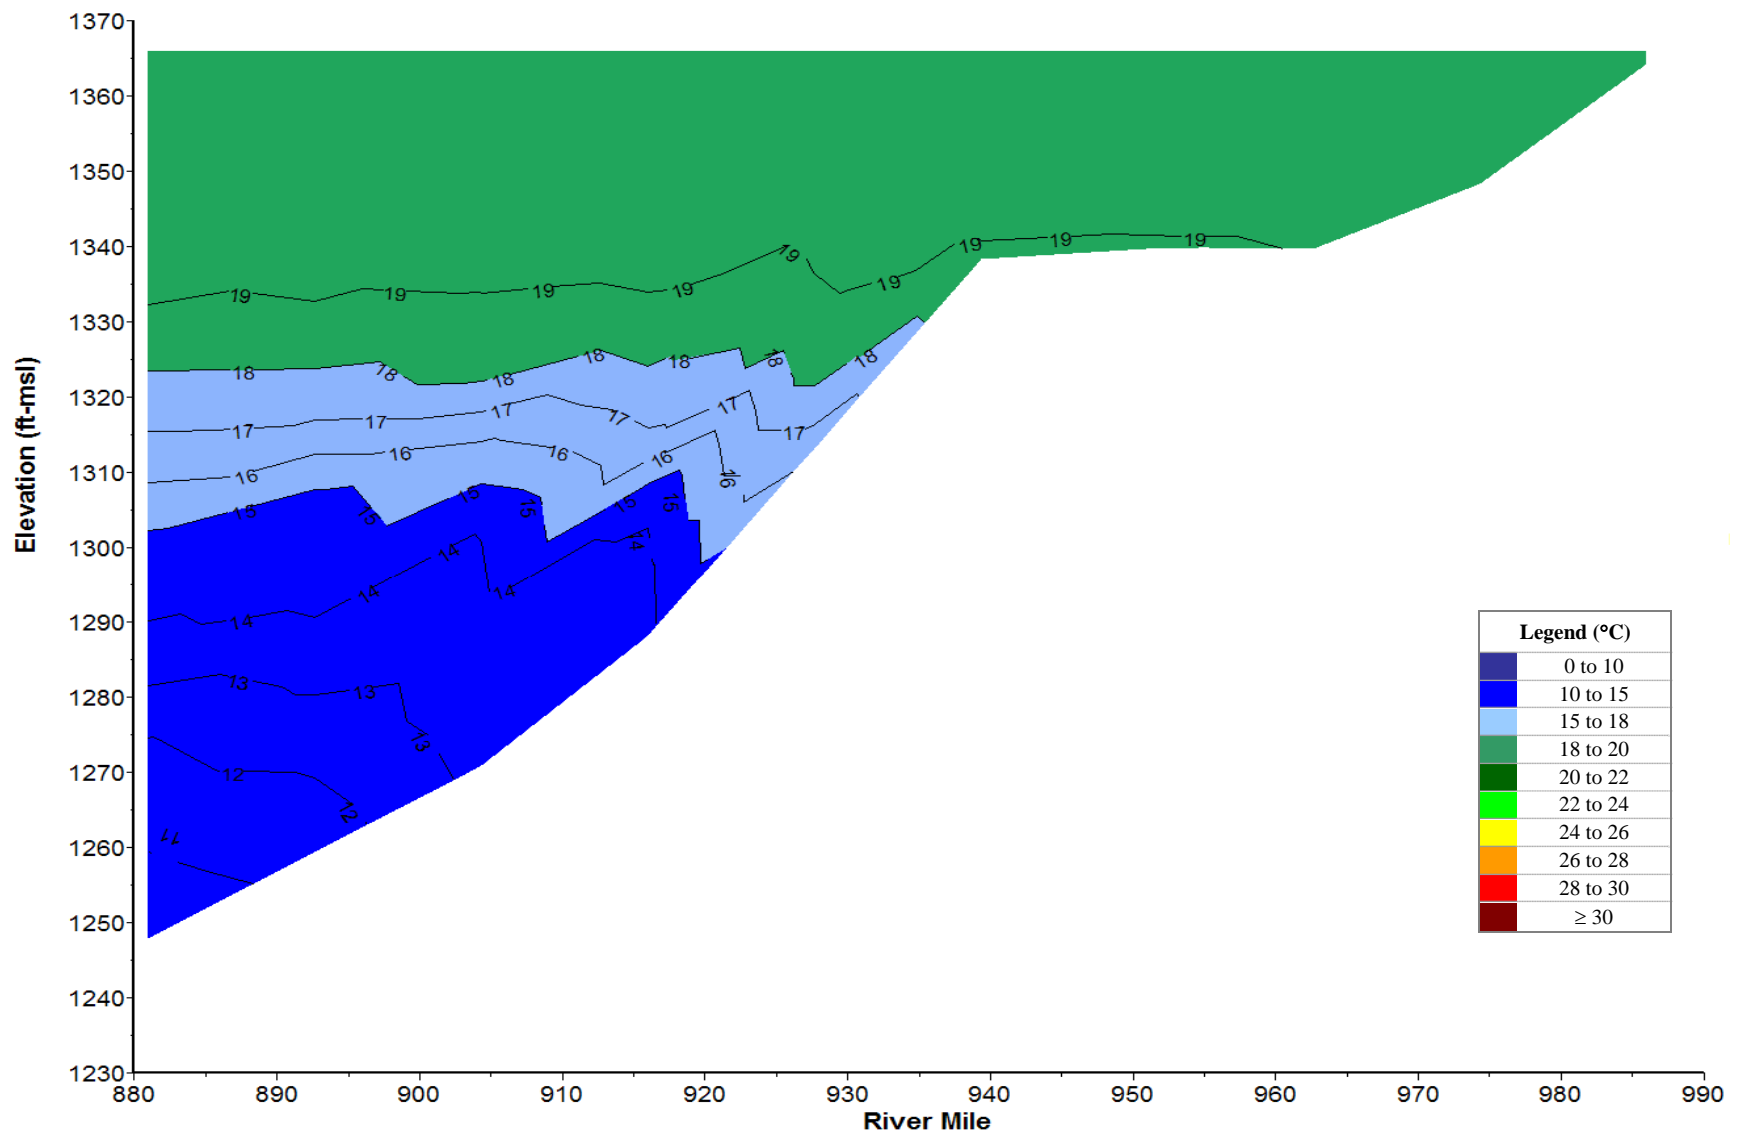
formed. The thermocline was located at about elevation 1300 ft-msl at a depth of about 20 meters (Figure 7).

Monitoring of Lake Francis Case on June 17, July 15, and August 12, indicated significant thermal stratification of the reservoir (Figures 7, 9, and 11). Monitoring on September 16 indicated that “fall turnover” had occurred and thermal stratification of the reservoir had broken down (Figure 13). The differences in surface and bottom water temperatures measured on June 17, July 15, and August 12, were, respectively, 9° C, 9° C, and 5° C. The depth of the thermocline on June 17, July 15, and August 12, was, respectively, 20, 25, and 30 meters.

Figure 7. Longitudinal water temperature contour plot of Lake Francis Case based on depth-profile water temperatures measured at RM880, RM911, RM 940, and RM968 on June 17, 2010.

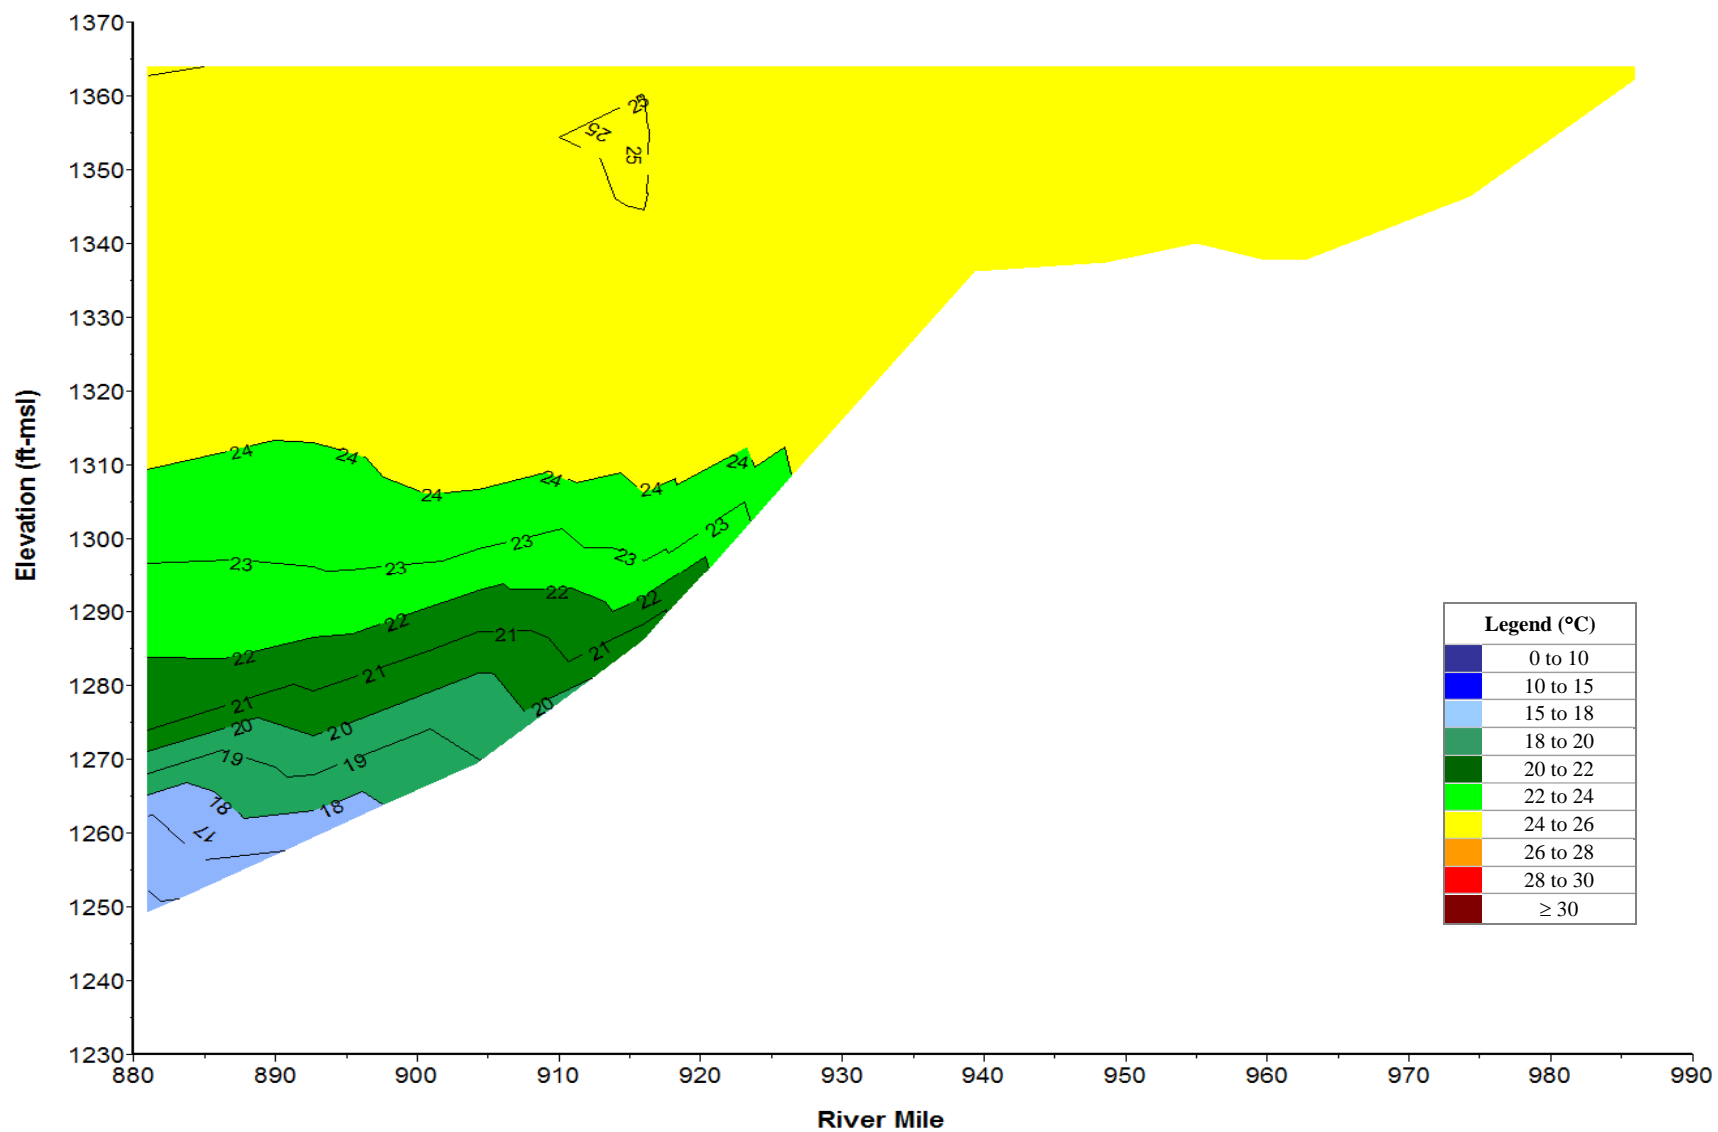
Water quality monitoring of the ambient monitoring sites on Lake Francis Case occurred on July 15, 2010. Longitudinal contour plots of water temperature and dissolved oxygen were constructed from depth-profile data collected at RM880, RM911, RM940, and RM968. Figures 9 and 10, respectively, show the longitudinal contour plots for water temperature and dissolved oxygen. On July 15, Lake Francis Case was thermally stratified and the thermocline was located at about elevation 1285 ft-msl at a depth of about 25 meters (Figure 9).

Figure 9. Longitudinal water temperature contour plot of Lake Francis Case based on depth-profile water temperatures measured at RM880, RM911, RM 940, and RM968 on July 15, 2010.

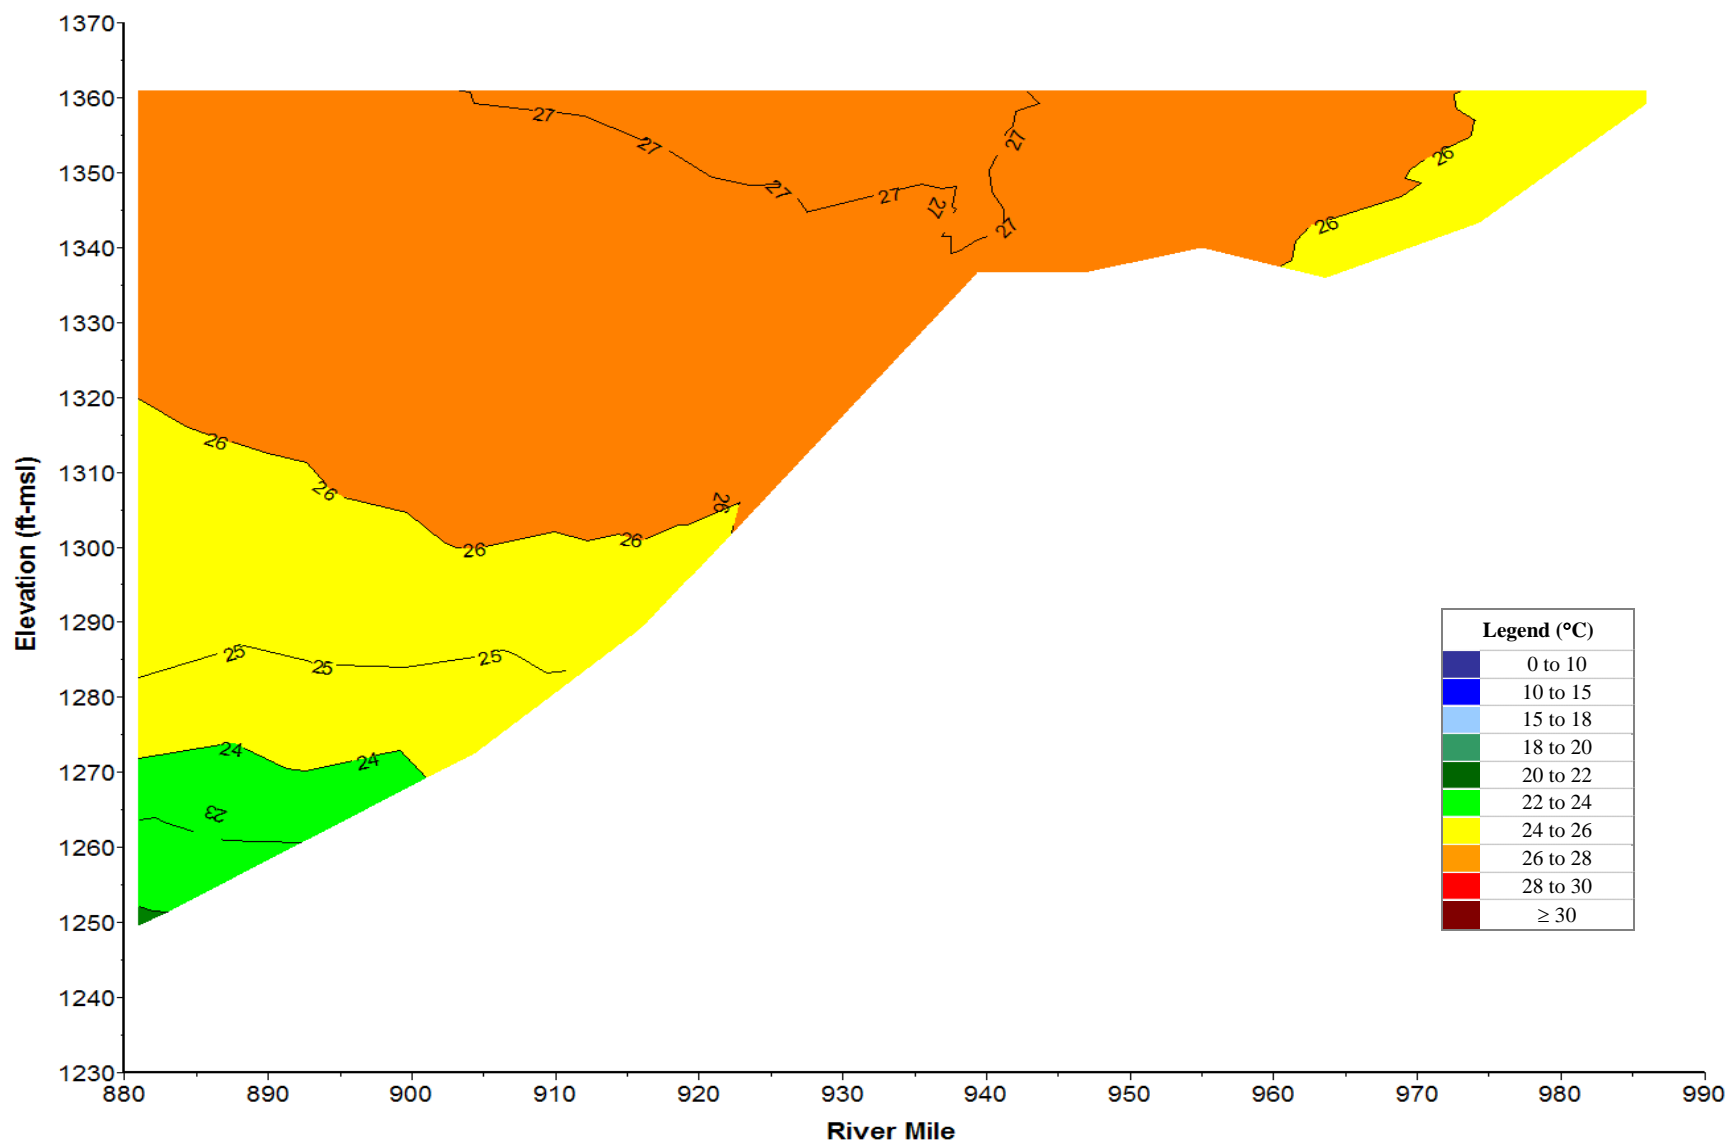
Water quality monitoring of the ambient monitoring sites on Lake Francis Case occurred on August 12, 2010. Longitudinal contour plots of water temperature and dissolved oxygen were constructed from depth-profile data collected at RM880, RM911, RM940, and RM968 on August 12. Figures 11 and 12, respectively, show the longitudinal contour plots for water temperature and dissolved oxygen. On August 12, Lake Francis Case remained thermally stratified and the thermocline was located at about elevation 1260 ft-msl at a depth of about 30 meters (Figure 11).

Figure 11. Longitudinal water temperature contour plot of Lake Francis Case based on depth-profile water temperatures measured at RM880, RM911, RM 940, and RM968 on August 12, 2010.

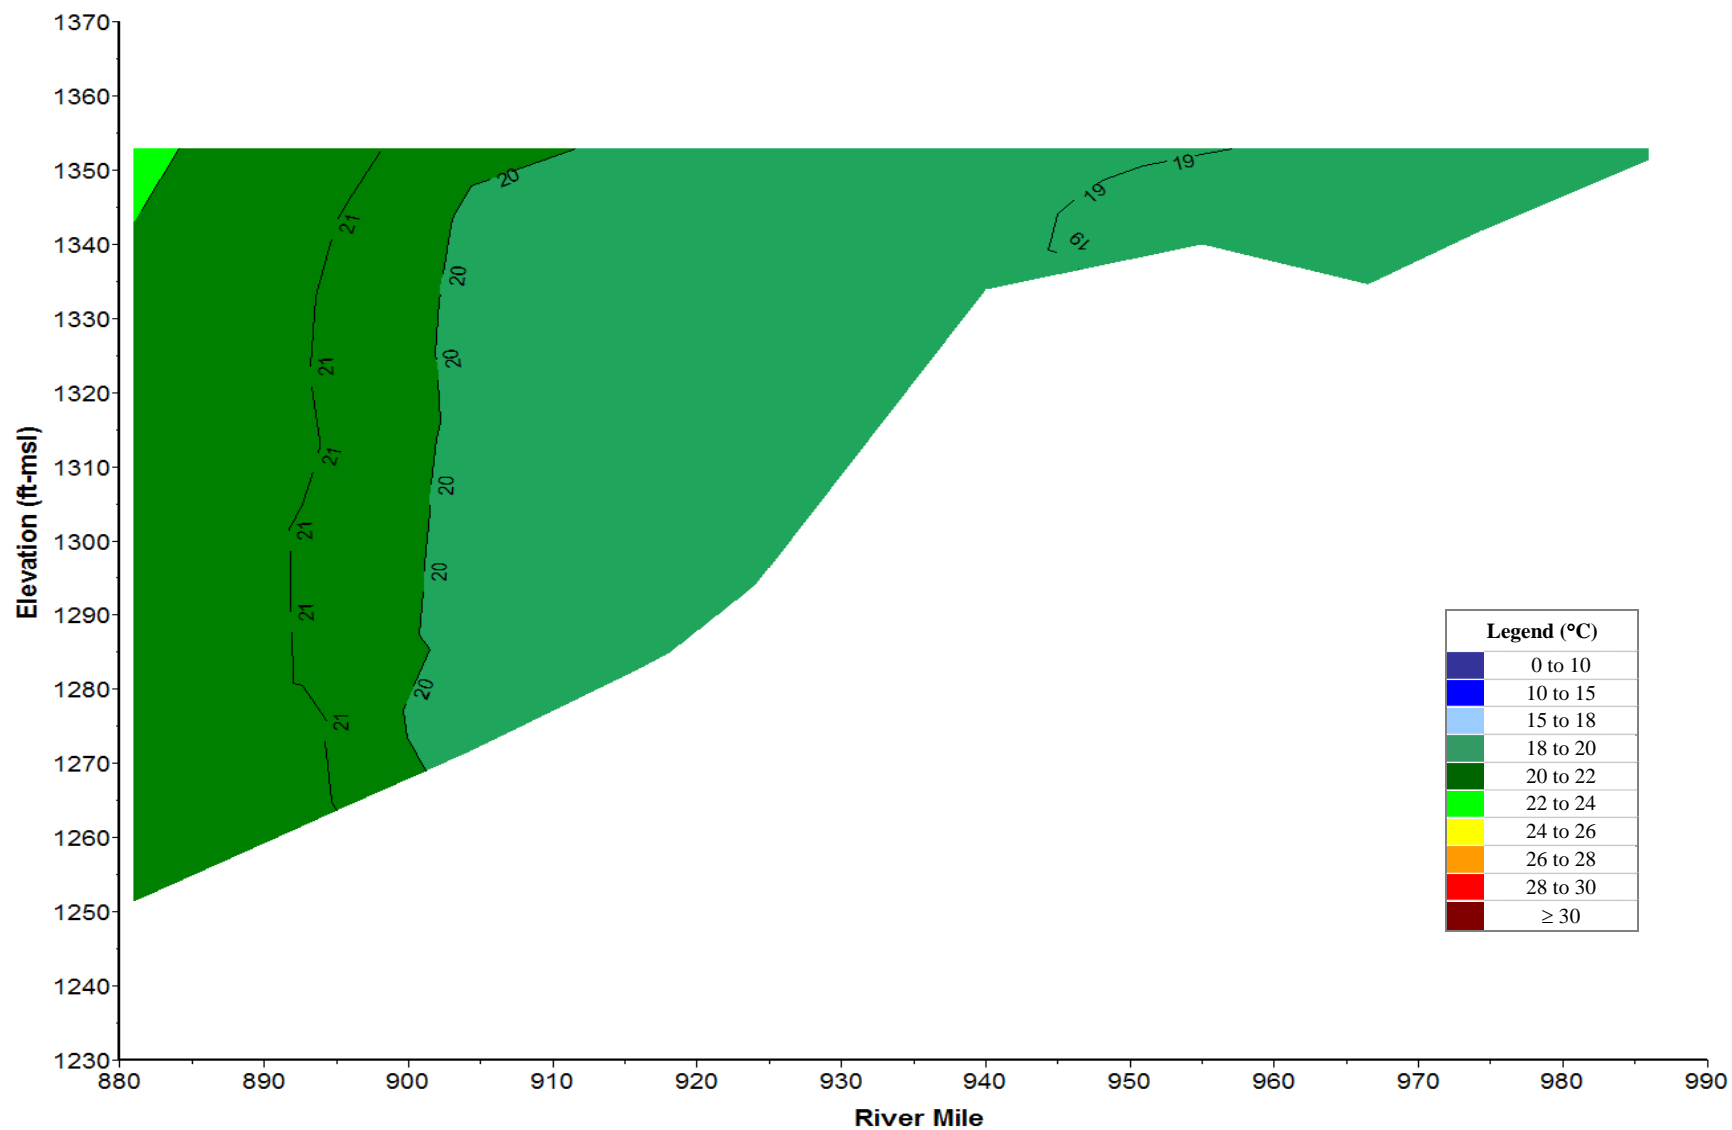
Water quality monitoring of the ambient monitoring sites on Lake Francis Case occurred on September 16, 2010. Longitudinal contour plots of water temperature and dissolved oxygen were constructed from depth-profile data collected at RM880, RM911, and RM968 on September 16. Monitoring at RM940 was not conducted because of an unusable boat ramp due to siltation and low water conditions. Figures 13 and 14, respectively, show the longitudinal contour plots for water temperature and dissolved oxygen. On September 16, Lake Francis Case was no longer thermally stratified (Figure 13).

Figure 13. Longitudinal water temperature contour plot of Lake Francis Case based on depth-profile water temperatures measured at RM880, RM911, and RM968 on September 16, 2010.

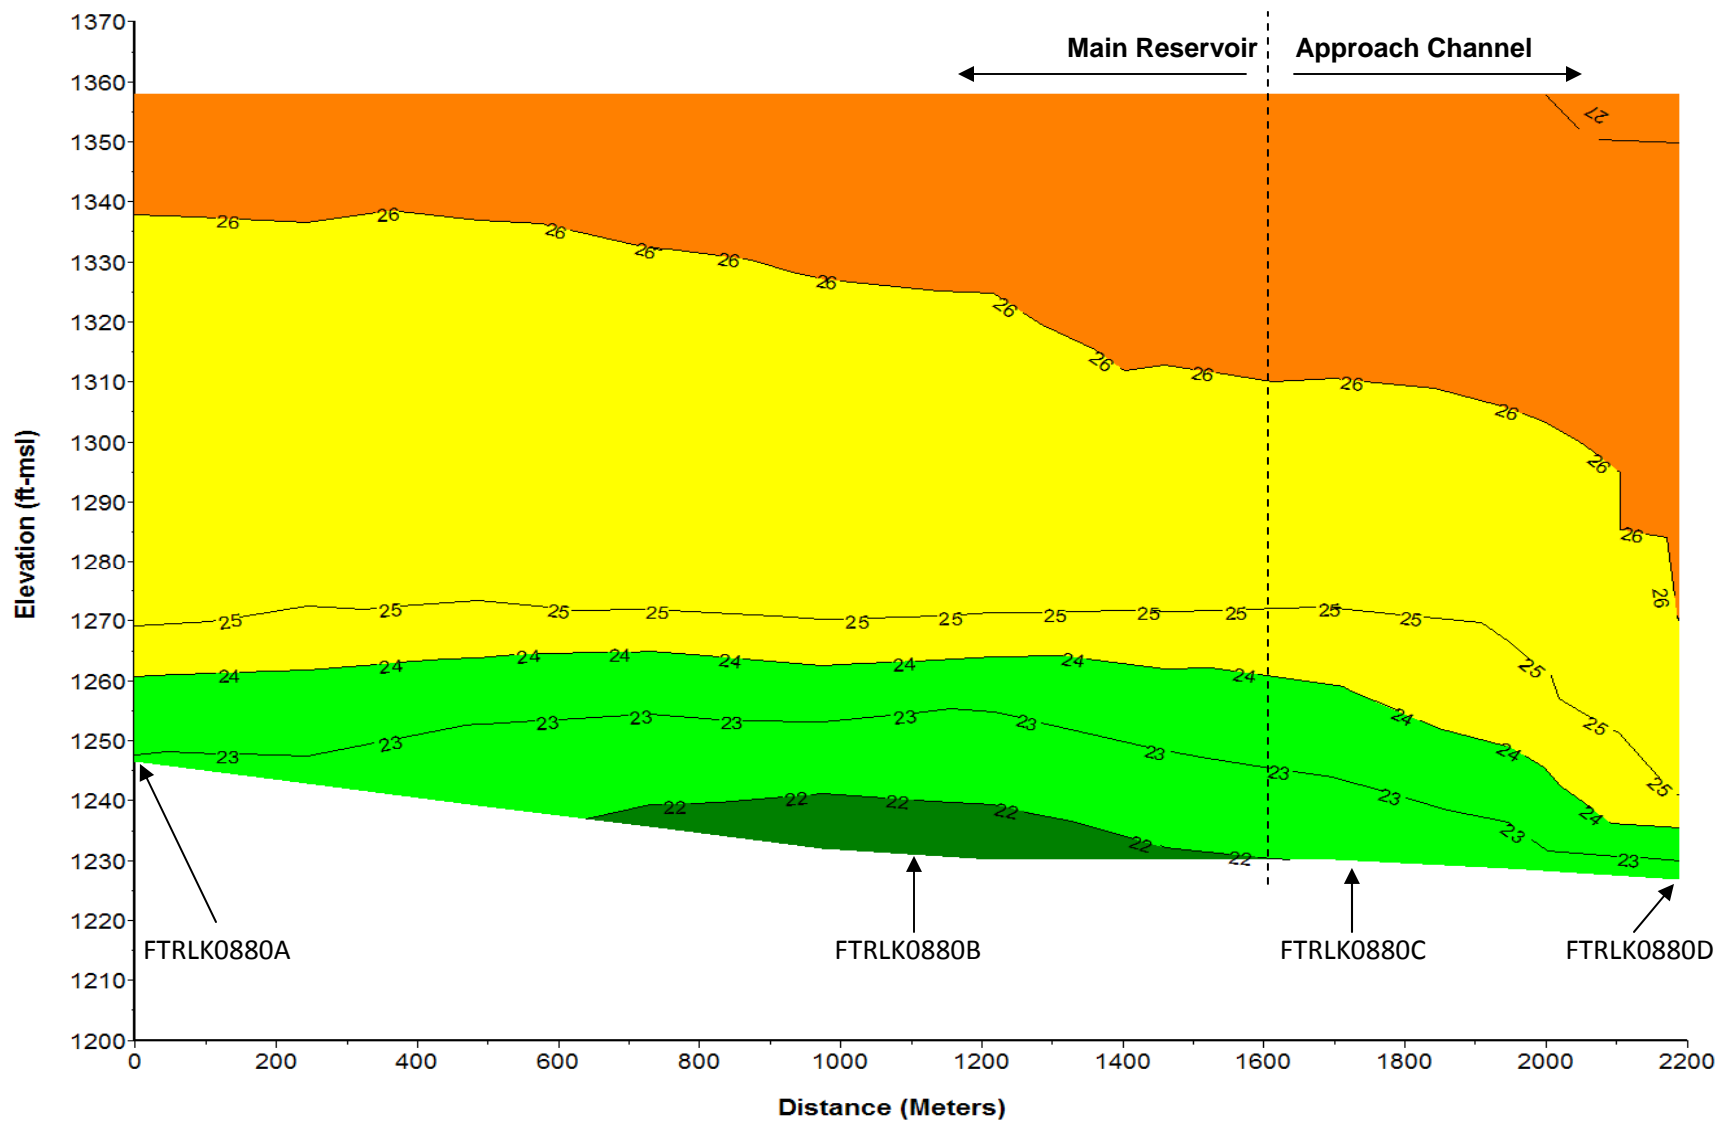
Additional water quality monitoring was conducted on August 19, 2010 to evaluate the variation in thermal stratification and dissolved oxygen levels in Lake Francis Case along Fort Randall Dam. Four sites were monitored in the deepwater region of the reservoir along the dam and submerged approach channel to the intake structure (Figure 15). At each for the four sites a depth-profile, in 1-meter increments, was measured for water temperature and dissolved oxygen. This information was used to construct a contour plot for water temperature and dissolved oxygen along the line through each of the four sites from site FTRLK0880A to site FTRLK0880D (Figures 16 and 17).

Figures 16 and 17 depict the thermal stratification and dissolved oxygen conditions that were monitored along Fort Randall Dam on August 19, 2010. The depicted area runs from the deepwater area of the submerged Missouri River channel (i.e., west side of the reservoir) to the east through the approach channel to the dam intake structure. Significant thermal stratification and hypoxic conditions occurred through this area (Figures 16 and 17). In the approach channel, warmer water with higher dissolved oxygen levels is seemingly drawn down from higher elevations in the area nearer the intake structure. This is attributed to “turbulence” created near the intake structure by the bottom withdrawal of water from the reservoir during higher inflows to the powerplant. The turbulence ostensibly allows warmer, less dense water higher in dissolved oxygen to be drawn down towards the reservoir bottom at the intake structure.

Figure 16. Contour plot of water temperature measured along Fort Randall Dam from monitoring site FTRLK0880A to site FTRLK0880D on August 19, 2010.

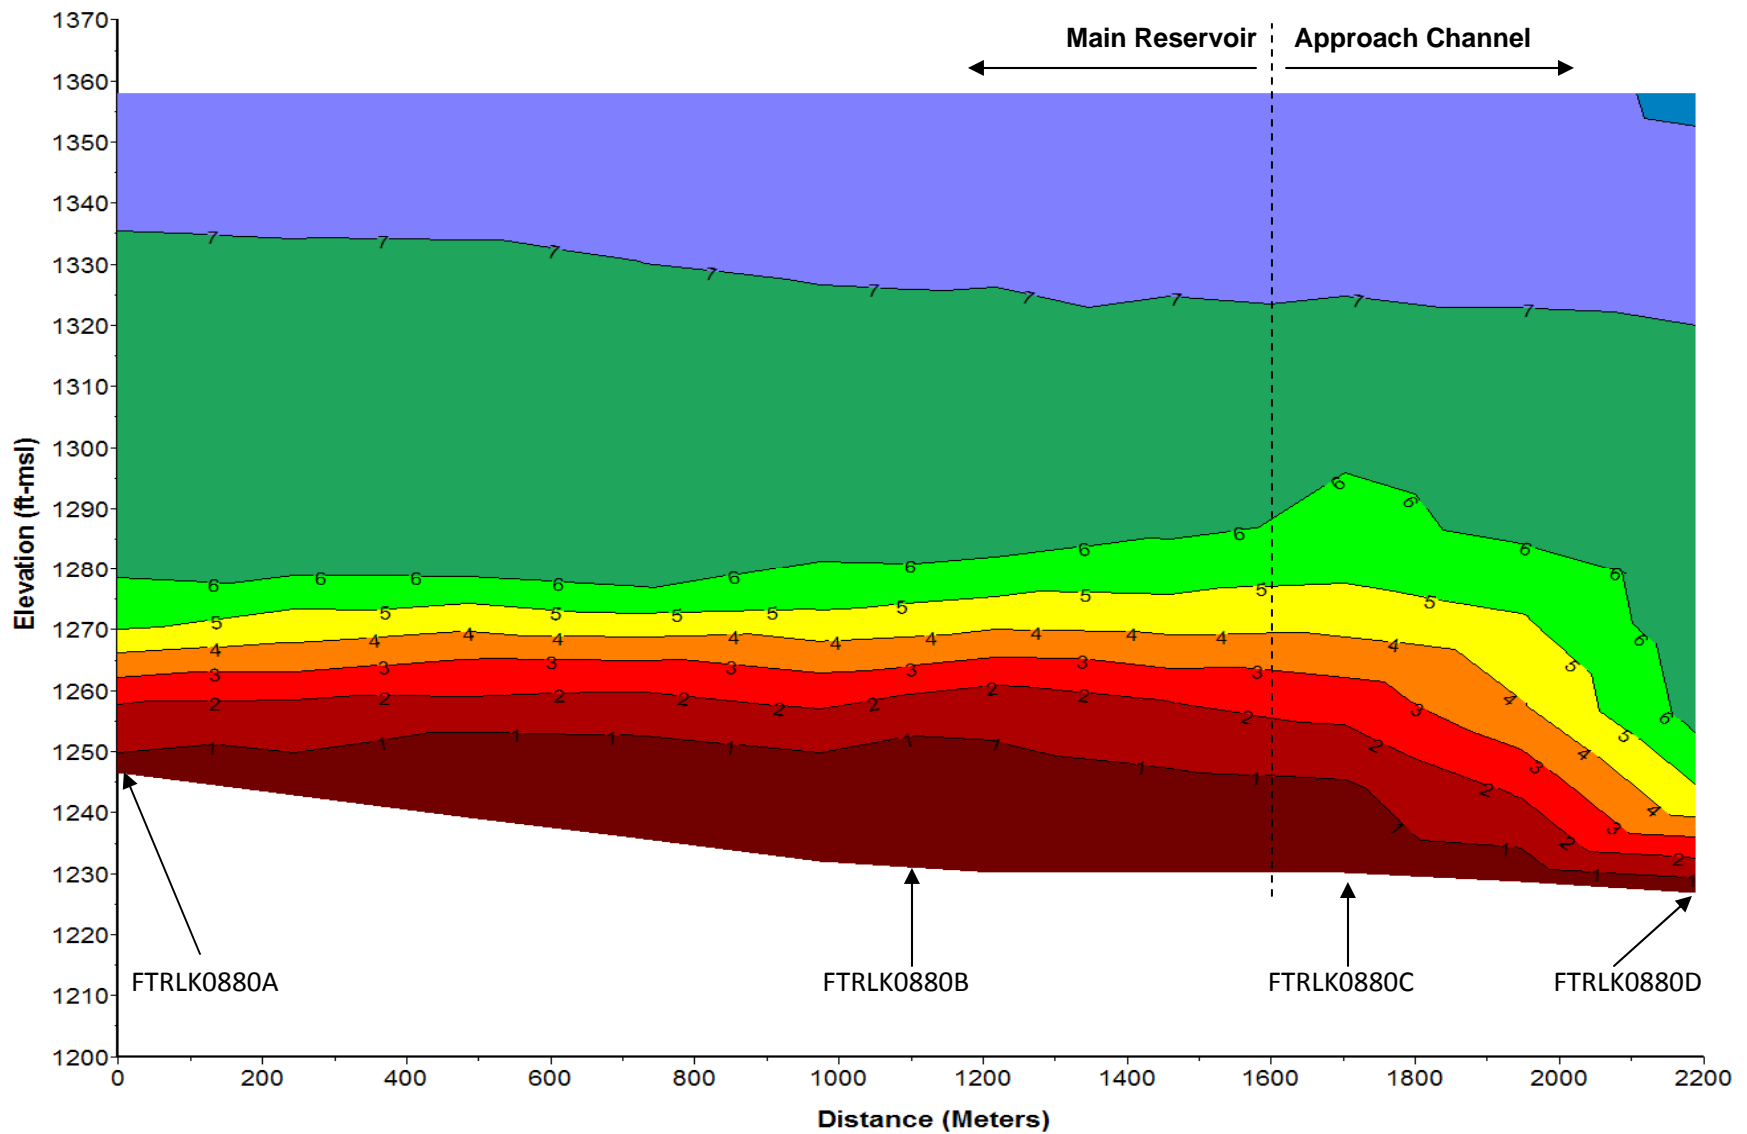
Figure 17. Contour plot of dissolved oxygen levels measured along Fort Randall Dam from monitoring site FTRLK0880A to site FTRLK0880D on August 19, 2010.
